**DOT/FAA/RD-93/40,1**

**Synthetic Vision  
Technology Demonstration**

**Volume 1 of 4  
Executive Summary**

**Final Report**

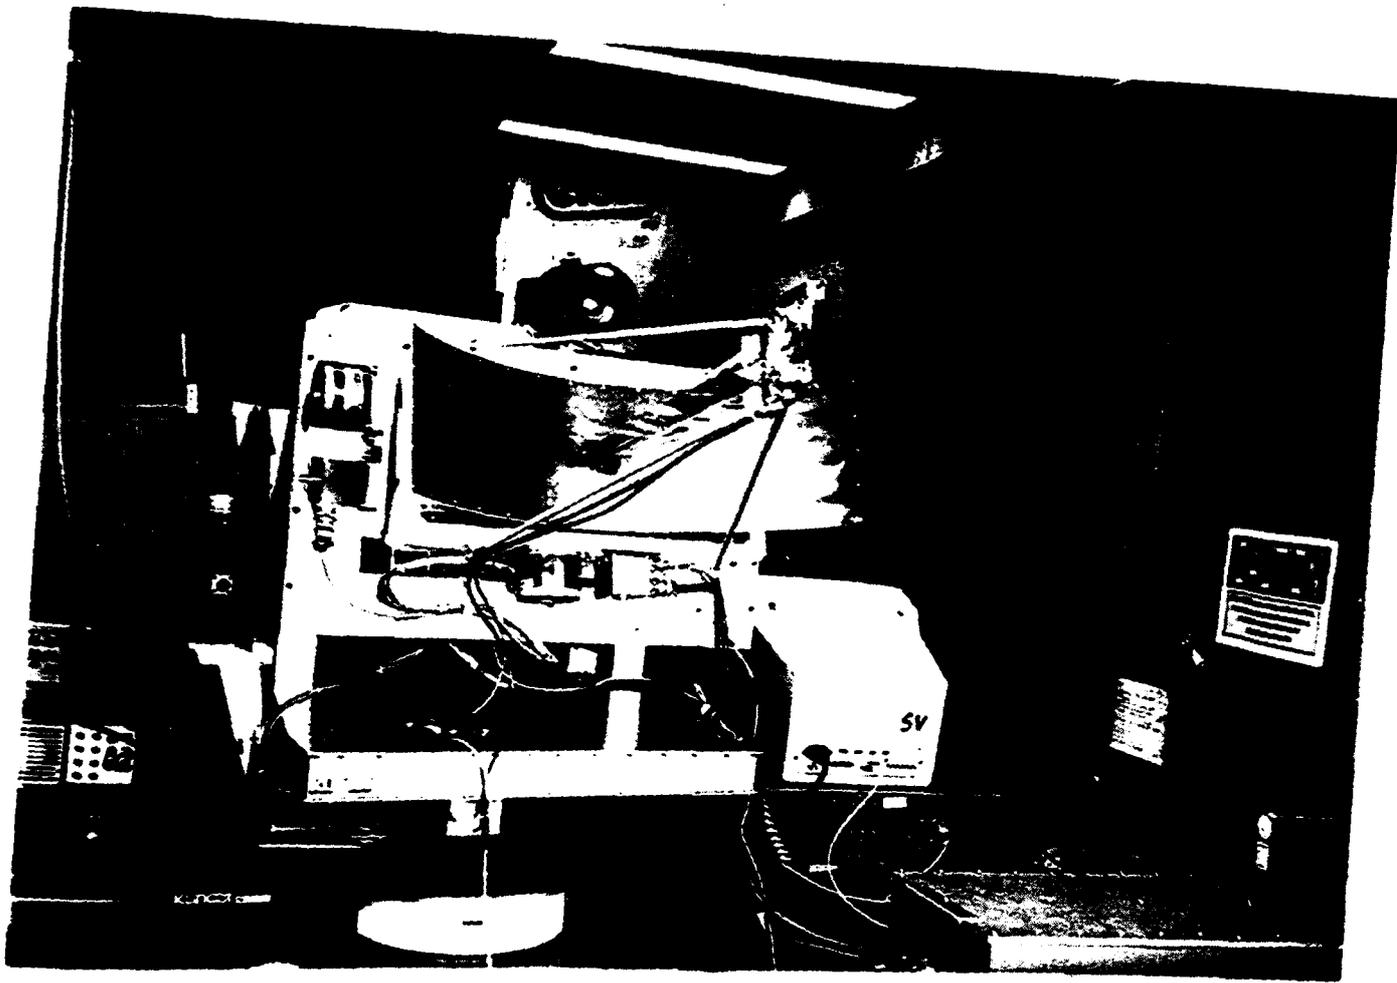
**Figure 4. Lear Astronics 94 GHz SVS Imaging Radar**

Because only one sensor, the Lear Astronics 94 GHz radar, was chosen for the competitive development, the project lacked the means to test and characterize 35 GHz performance. A search for 35 GHz sensors yielded a relatively low cost solution; an existing radar built for another Air Force application. To be assembled with components from the manufacturer, Honeywell, Inc., and the Air Force, this system would be tested at the tower to obtain the desired 35 GHz

performance and phenomenology data. The project funded fabrication of a new electromechanical scanning antenna, built by Malibu Research Associates, that was designed in a form and fit suitable for potential flight tests. As a result of this activity, the program would not only obtain 35 GHz data, but also a backup sensor for the flight tests, in case the higher risk 94 GHz radar development was not successful.

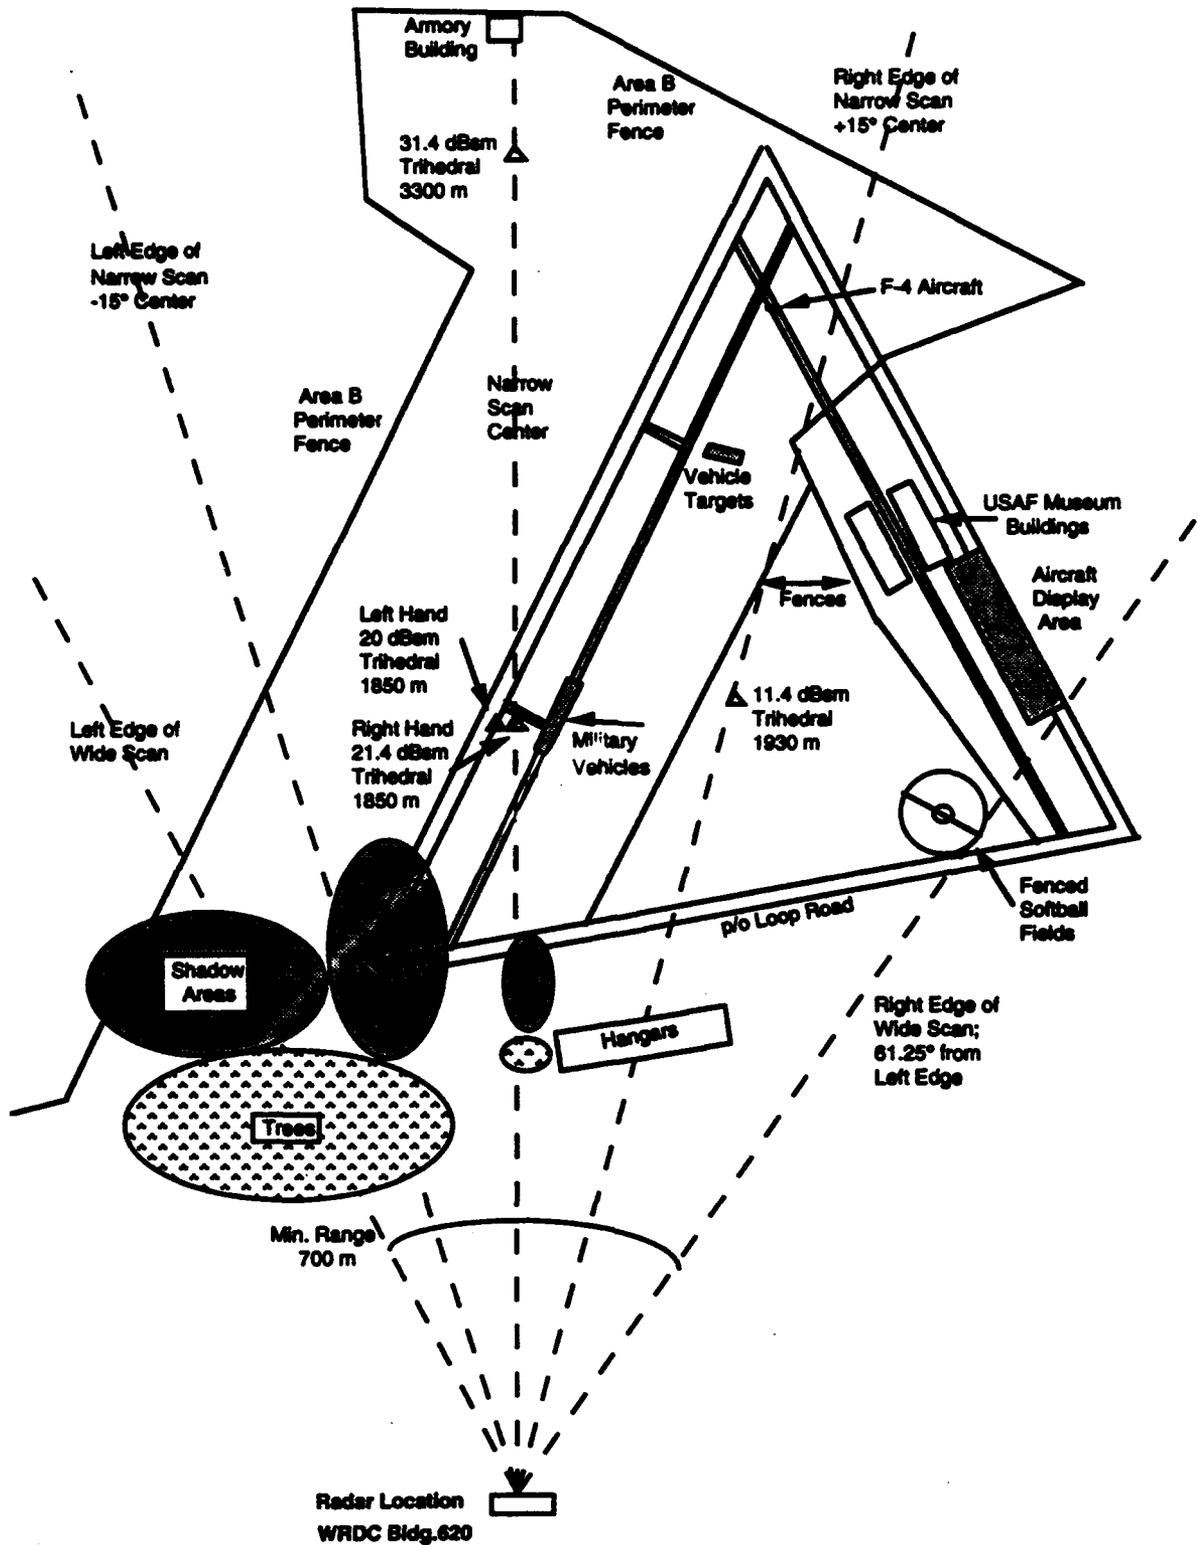
**Figure 7. Top View Drawing of Test Area**

The Tower Test Plan required that baseline tests of each sensor be conducted to calibrate the system parameters and provide the ideal clear air performance control data set for comparison with sensor performance in fog, rain and snow. The planned test matrix called for a minimum of twelve complete data runs of four different weather categories with three runs each. The four categories were clear air, fog, rain and snow. The maximum prevailing visibility for the latter three categories was 1 1/2 miles. For the infrared sensors, 24 hour duration diurnal baseline tests were conducted because of the performance dependencies on sun angle, thermal history, and time of day.

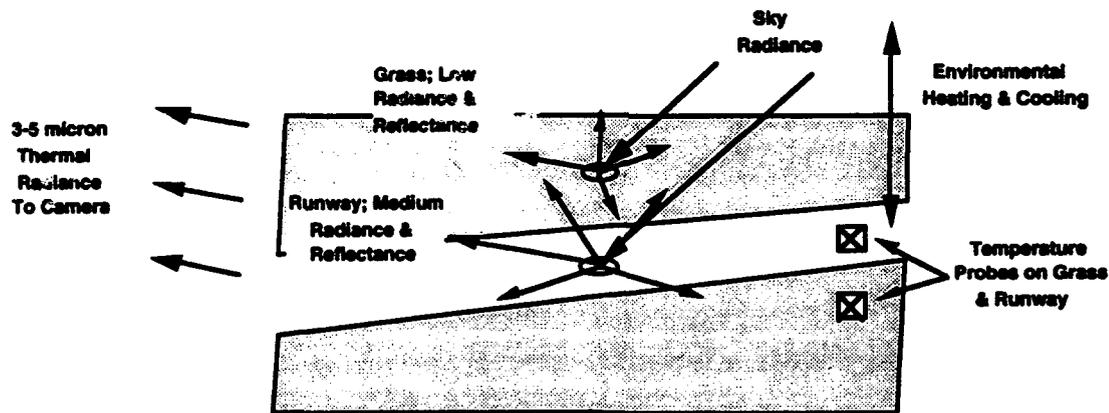
Figure 10. IR detection of a runway.

wavelength range accepted by an IR camera is based on the type of sensitive detector element used. Image contrast is developed by the differences in radiance received from the typically warmer pavement and the typically cooler grass areas within an airport scene. The actual radiance difference is a function of environmental heating and cooling during the daily cycle, grass moisture, and meteorological events.

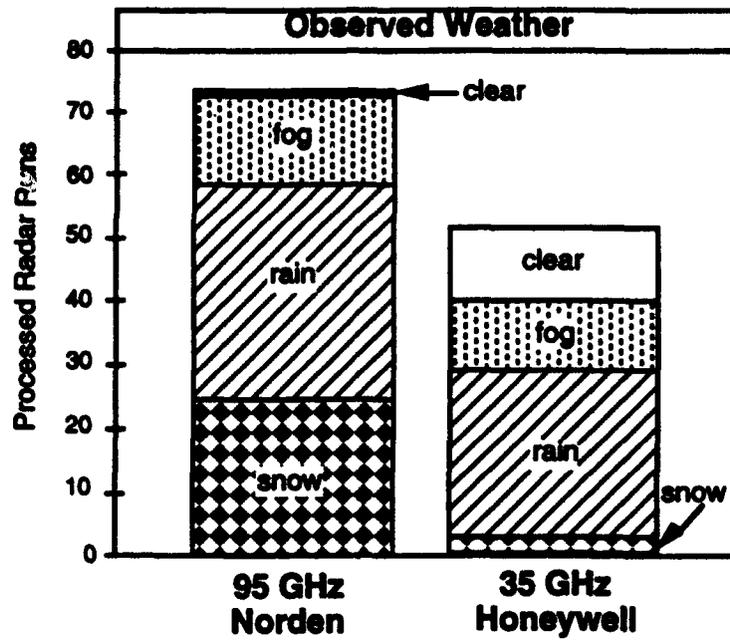
Figure 13a. MMW Test Data Matrix Sorted by Observed Weather.

The tower test data matrix for the Honeywell 35 GHz (HI2) and Norden 95 GHz (NS1) radar sensors is presented in Figure 13a, grouped by observed weather conditions, and in Figure 13b, sorted by along-path visibility (LPV) in feet. Although there were several runs with weather conditions of fog, the visibility was usually greater than 1,700 feet (520 m). Conditions of low-visibility fog did not occur at the tower during the sensor test periods. Note that the numbers of measurement runs listed are those that were processed by GTRI from among a larger set that were collected. Table 5 presents a more detailed MMW data matrix for all six sensor configurations tested. The total numbers of runs collected and processed for each sensor configuration are shown, along with the numbers of processed runs sorted by meteorological conditions.

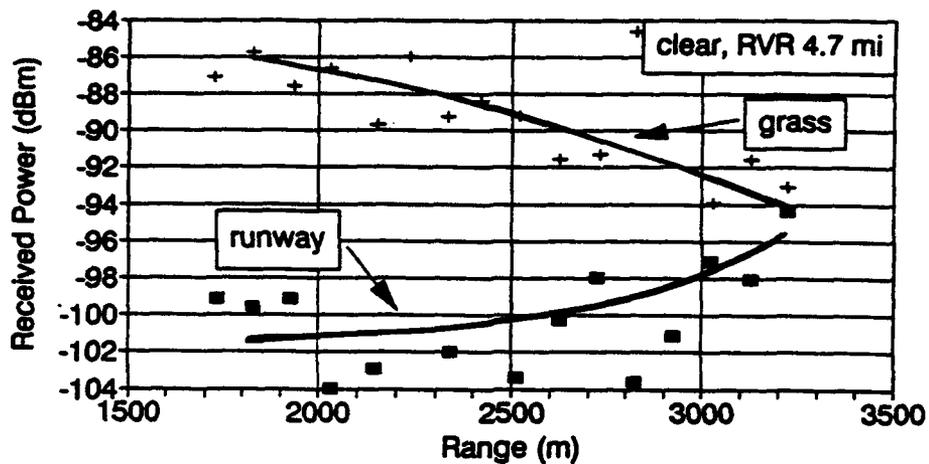
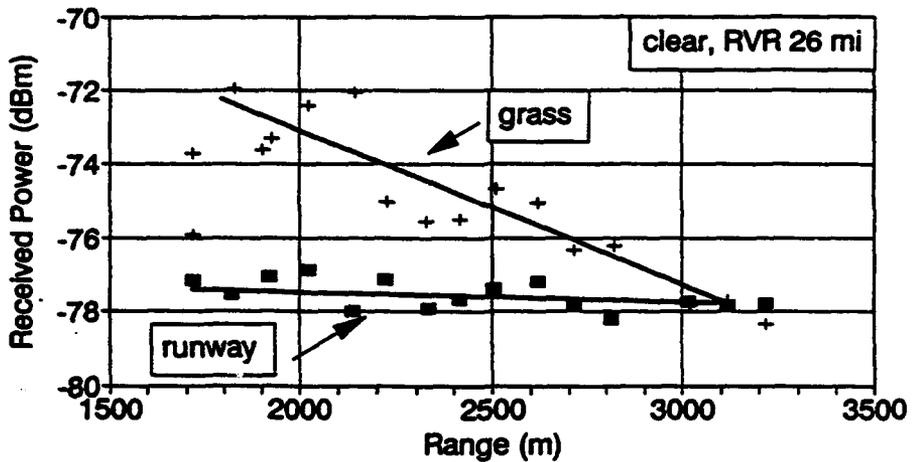
Downrange profiles of equivalent received power are a good method of rating a MMW radar sensor's ability to discriminate the runway from the bordering grass areas. As described in Volume 2 (Sensor Tower Testing) of this report, a series of patch areas were defined along the runway and grass for data processing purposes. A downrange power profile plot presents the equivalent received power values from the patches spaced along the grass and runway between 1,700 m and 3,300 m range. Figure 15a is a downrange power profile for the 35 GHz radar, and Figure 15b is the same profile for the Norden 95 GHz radar sensor. Figure 16 is a similar profile for the Lear Astronics 94 GHz radar sensor. Curves have been fit to the points from the grass patches (plus signs) and the runway patches (solid squares). The difference in received power between the grass patches and the runway patches provided by the radar sensor is converted by the signal processor into image contrast. This power difference decreases with range and in weather, reducing the resulting image contrast and the detectability of the runway.

Figure 15a. 35 GHz Downrange Power Profile

Figure 15b. 95 GHz Downrange Power Profile

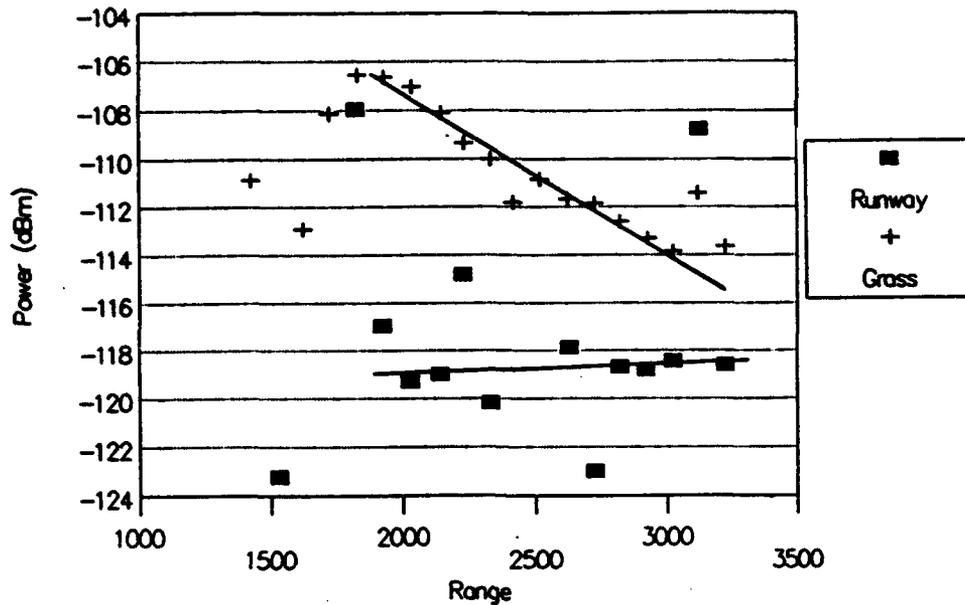
Figure 16. 94 GHz Downrange Power Profile

8/15/92 LA2T06 clear

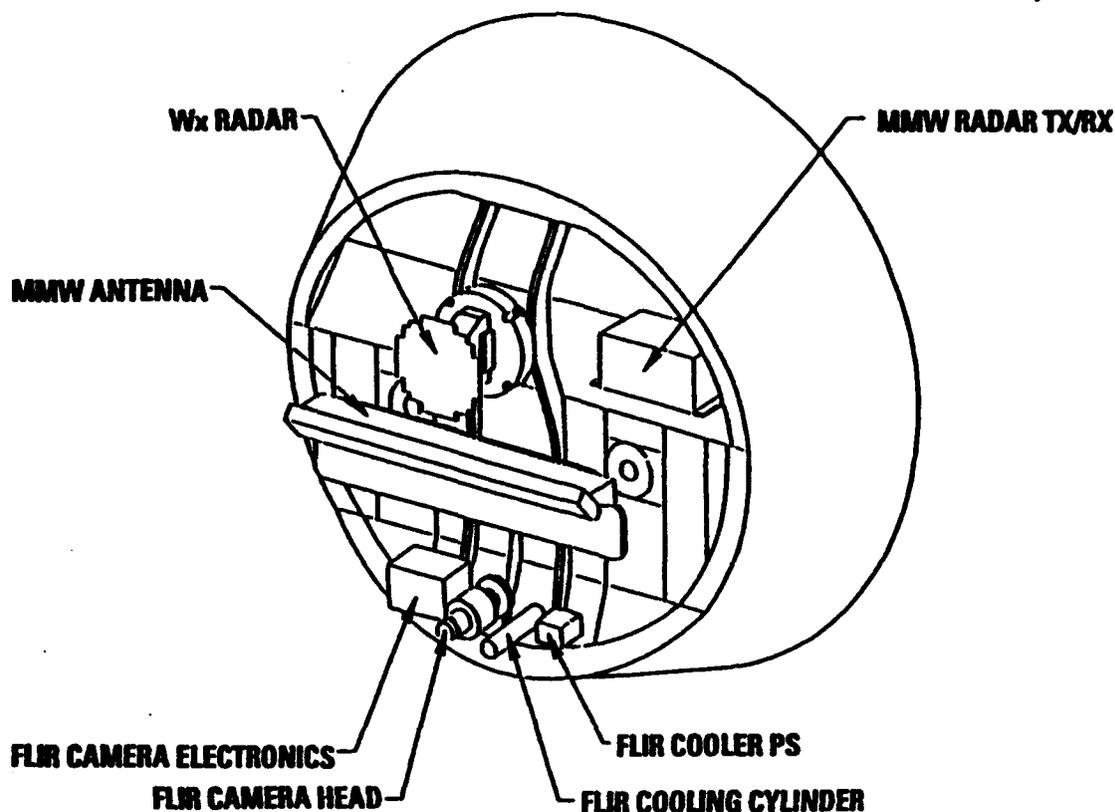
Figure 19. 35 GHz Sensor Installation in Test Aircraft

## 35 GHz MMW Sensor Arrangement

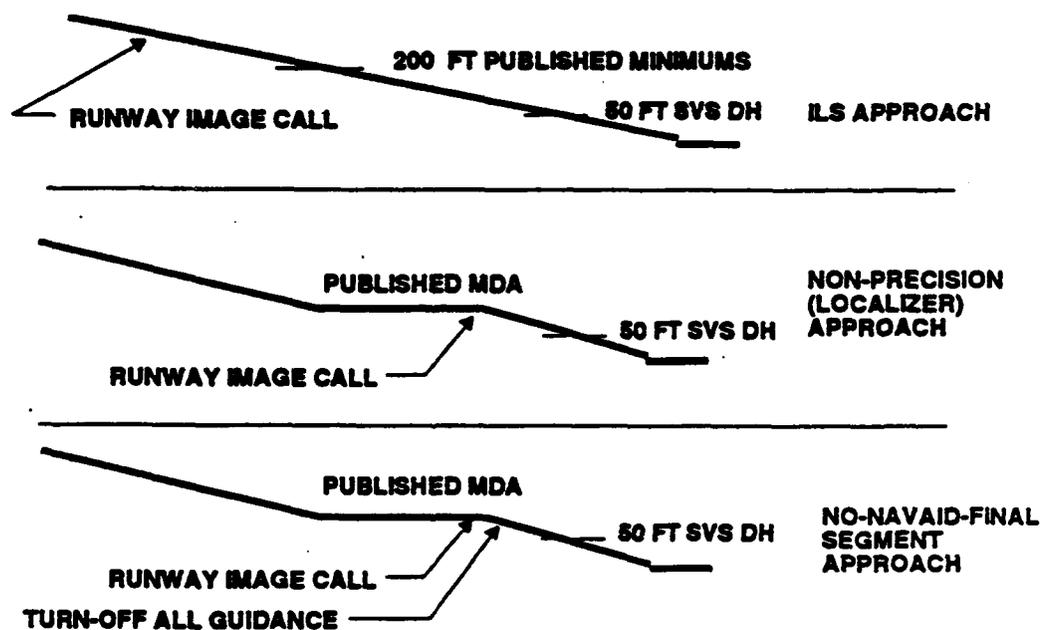
Figure 25. Approach Procedures Used in Flight Test Program

vertical speed hold for non-precision approaches, and the raw-data glideslope information was not displayed on the HUD. The no-navaid-final-segment approach was conducted in an identical fashion to the localizer approach except that the test director detuned the ILS localizer frequency after hearing the pilot call "runway image". This required the evaluation pilot to rely only on the HUD image and symbology (without flight director or ILS guidance) for guidance. The safety pilot always had full ILS glideslope and localizer information on his displays. For most simulated IMC approaches the cardboard shield was in place in front of the HUD down to an altitude of 50 feet. A few ILS approaches were conducted to Cat IIIc (0/0) minimums, and a few were conducted to Cat II (100 ft DH) minimums.

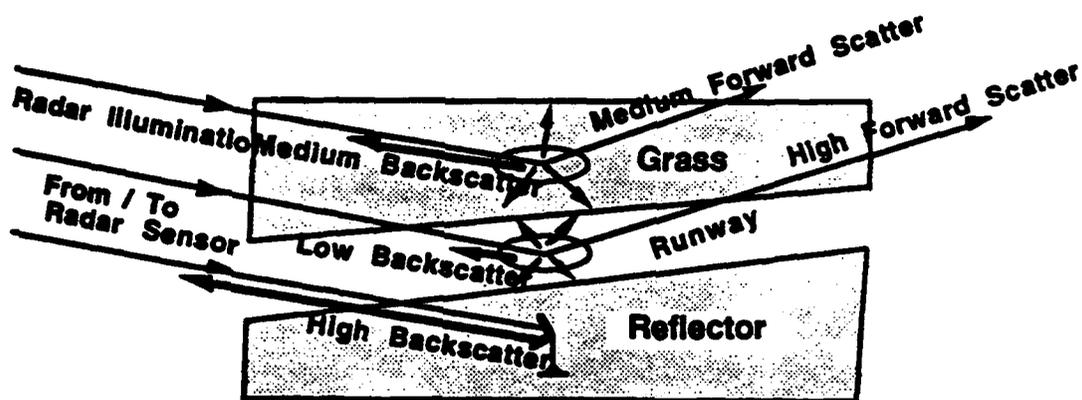
Figure 26. Illustration of Radar Reflectivity

Three parameters can be defined using the gutter plot which it was felt might be useful in characterizing how well the runway can be distinguished from the surrounding terrain. Contrast is a function of the average signal level received from the runway relative to that received from the surrounding terrain.

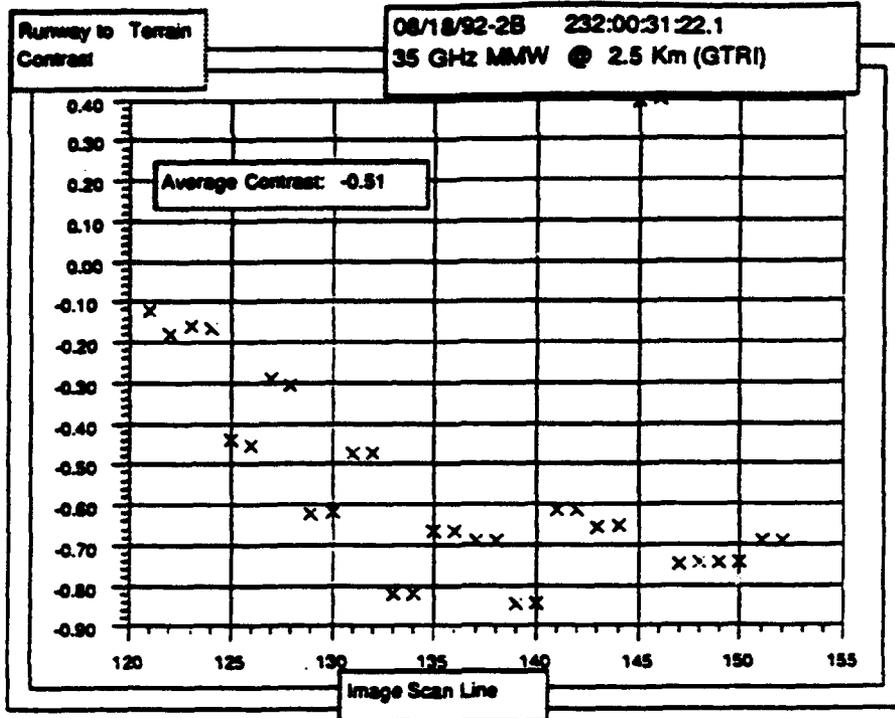
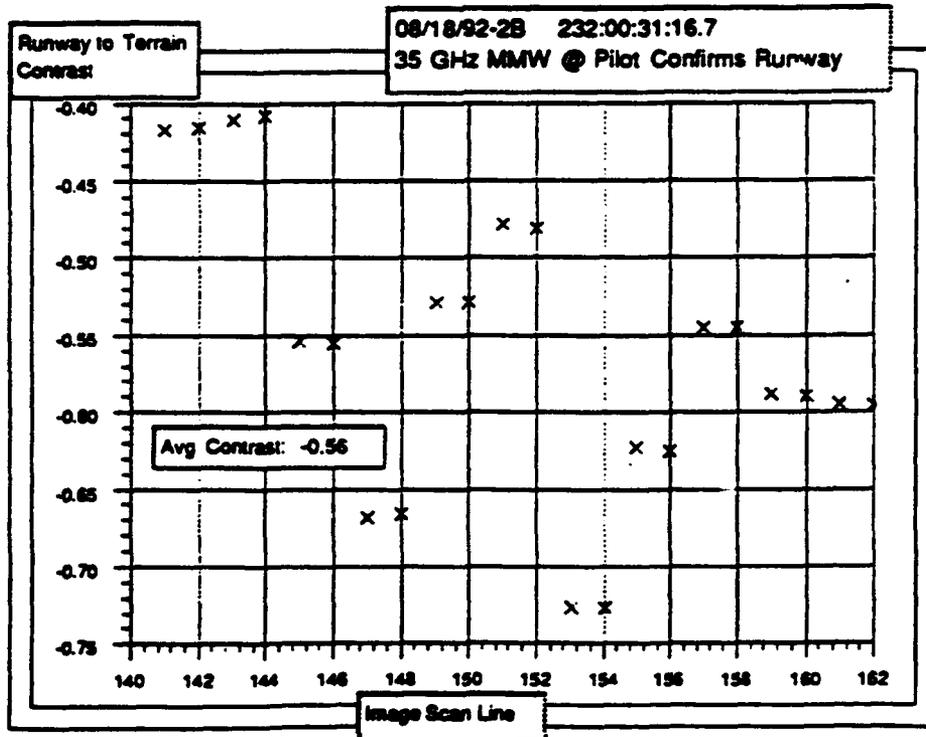
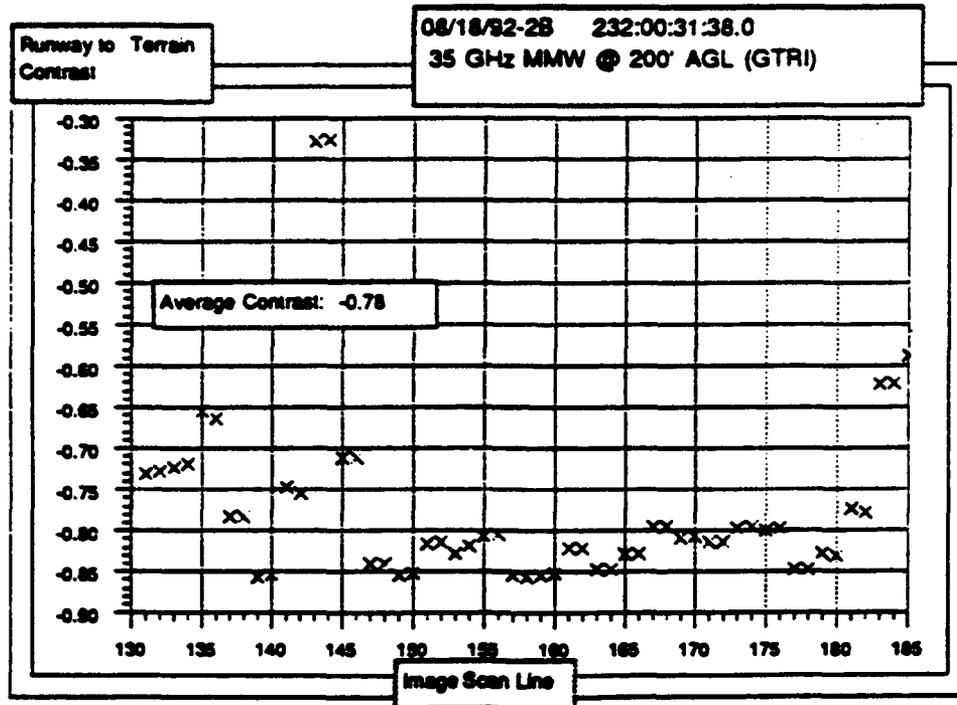
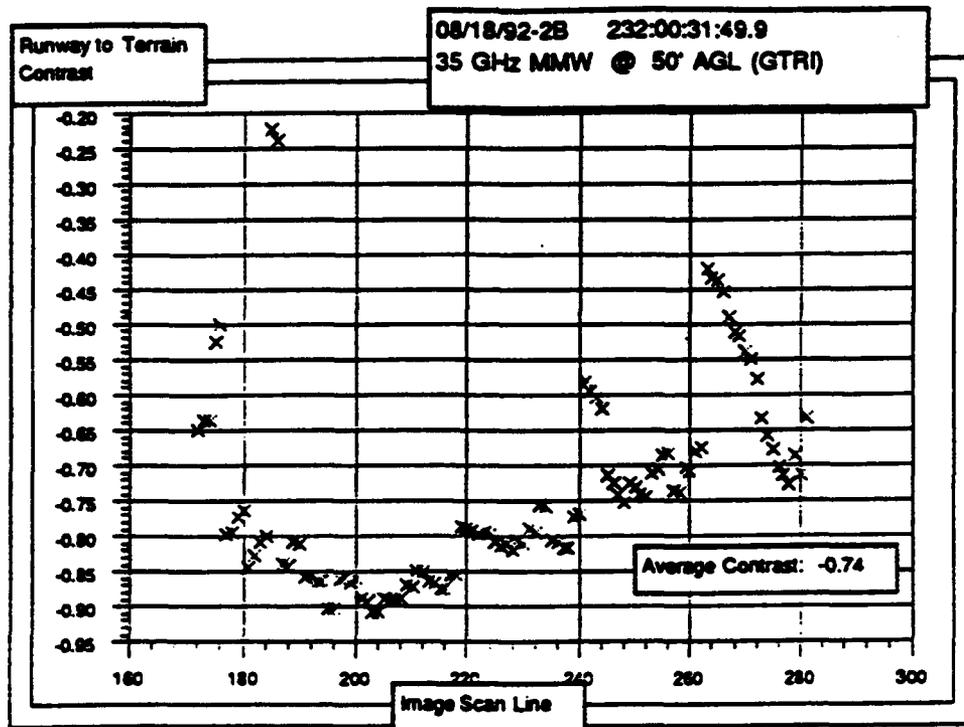
Figure 29. RS-170 Video Contrast - August 18, 1992-2B (NTD at 2.5 km)

Figure 30 . RS 170 Video Contrast - August 18, 1992-2B (NTD at Pilot Confirms Rwy)

Figure 31. RS 170 Video Contrast - August 18, 1992-2B (NTD at 200 ft AGL)

Figure 32. RS 170 Video Contrast - August 18, 1992-2B (NTD at 50 ft AGL)

Variability and sharpness were considered as possible metrics for image recognition. However, analysis of variability and of sharpness in the video data was not done when the GTRI studies showed that they had a very low correlation in the raw radar data which form the video data.

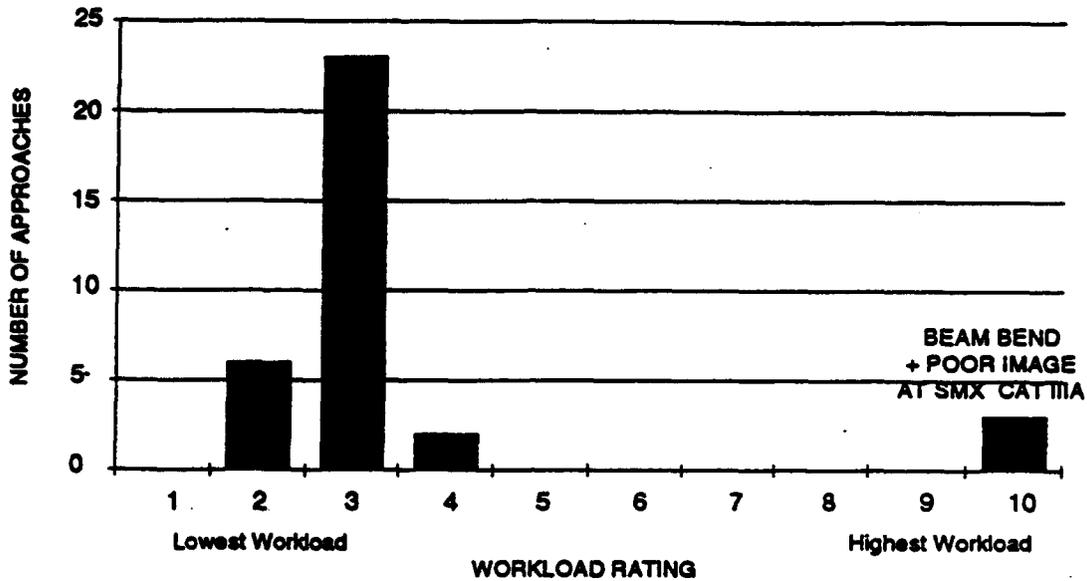
**Figure 36. Frequency Distribution of Pilot Workload Rating Data for Actual Cat II and Cat IIIa Approaches**

A frequency distribution of the pilot subjective workload ratings for approaches and landing flares in conditions below Cat I minimums is shown in Figure 36. Twenty-nine of the approaches received ratings of 2 and 3, two approaches were assigned a 4, and three approaches were rated 10.

#### a) Workload Ratings for Approach Segment From an Altitude of 250 ft to 50 ft

#### b) Workload Ratings for Flare
